# Maralinga: The Clean-Up of a Nuclear Test Site

Alan Parkinson, BScTech, MScSoc

Plutonium and uranium fallout from 15 nuclear tests conducted by the British government between 1961 and 1963 contaminated Aboriginal lands. Although the British government declared the Maralinga site safe following a 1967 cleanup, surveys in the 1980s proved otherwise, prompting a new cleanup project. Conflicts of interest, cost-cutting measures, shallow burials of radioactive waste, and other management “compromises” have left hundreds of square kilometers of Aboriginal lands contaminated and unfit for rehabilitation. M&GS 2002;7:77-81.

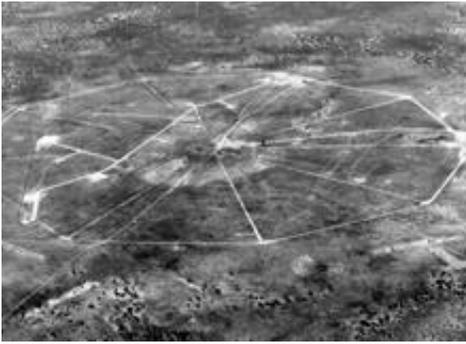
The Taranaki nuclear test site.  
Photo courtesy of Alan Parkinson.
